Environment Agency Recovery Works Old River Ancholme and its tributaries

Summer and autumn 2019 rainfall

Recovery work sites

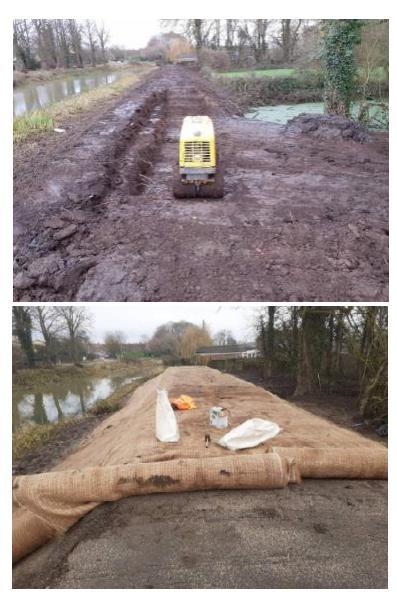
After Christmas the 2nd stump location was compacted, clay shaped and formed to the original profile as shown in these three pictures left and below. Netting to reduce burrowing was laid and covered with 200mm of topsoil.

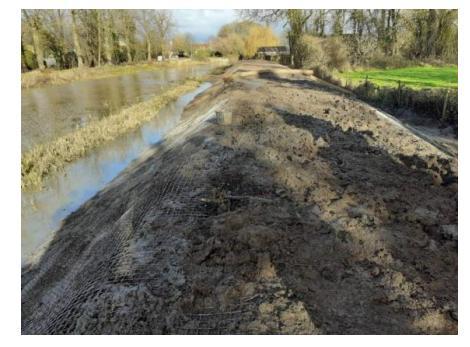
Post Storm Christoph at **Site 1**, the field used for access was flooded for 3 days and contractors relayed the trackway to higher ground to regain embankment access.

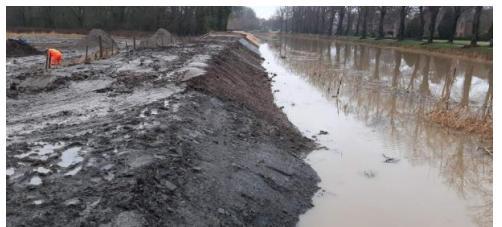
Early February weather again impacted work. The photograph below left is of water levels as of 3rd February.

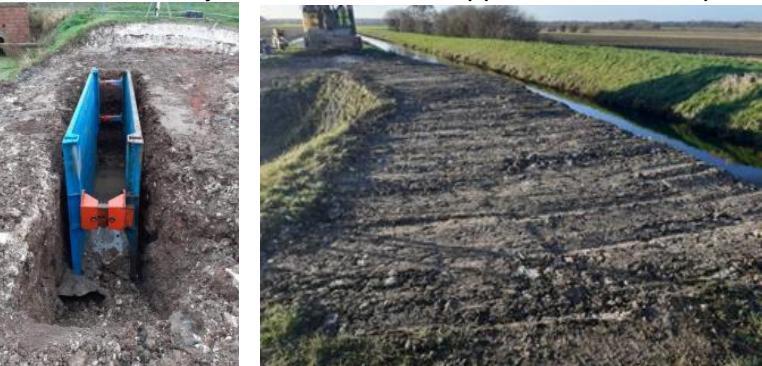
Before the Christmas break the south side of the highland carrier had been excavated, completed and re-instated back to height for the holiday period.

This allowed for any settlement which appeared over that period to be topped up if required after Christmas.

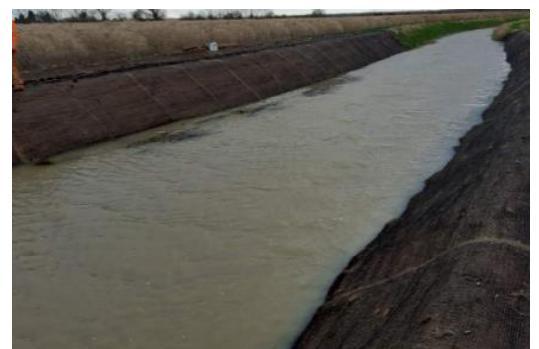
A gang started operations on the north side of the embankment shown in the picture on the left.

This included a topsoil strip of the 12m section to be rebuilt. However, following heavy rain and resulting high water levels, the excavation work ceased.

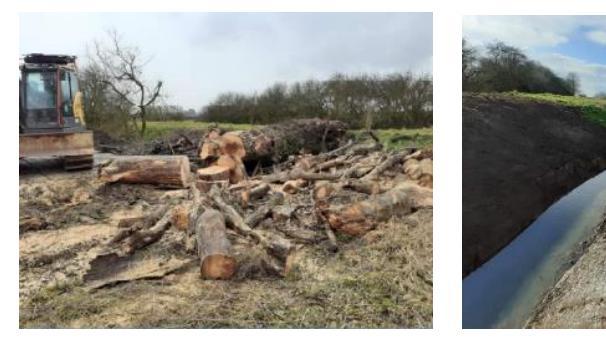
Favourable weather conditions in the last week or February permitted removal of the fallen tree which was cut and removed from site. A 15 ton excavator had the reach to repair both bank sides with compacted clay and top soil. Seeding remains to be done following

which a protective blanket will be used until the grass has grown through.

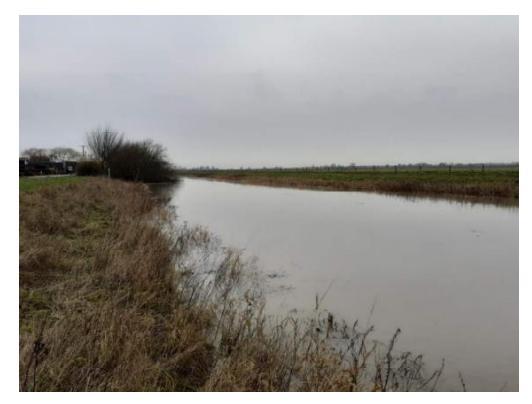
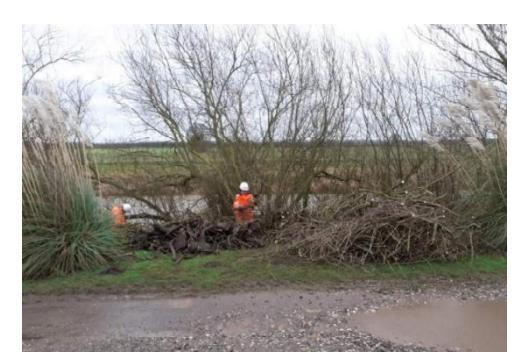
River Ancholme at Snitterby Carr

Recovery work at this site is associated with toe erosion and bank slippage across a 40m length of embankment. By January this site had been

Work in the last week of January progressed well; willow trees landside of the river were removed and chipped allowing access to bank base. All required materials were on site including 80t of compacted clay to provide a working platform from which to place the stakes, brushwood faggots and coir rolls. Unfortunately by mid-day at the end of the week, the river was too high for
