JBA Project Code	2012s6108
Contract	Danvm Drainage Commissioners BAP Implementation
Client	Danvm Drainage Commissioners
Date	October 2014
Author	F Tobin
Subject	BAP Implementation 2014-15 – Water Vole Surveys

1.1 Biodiversity Action Plan (BAP) Implementation – Water Vole Surveys (BAP Action 15.3)

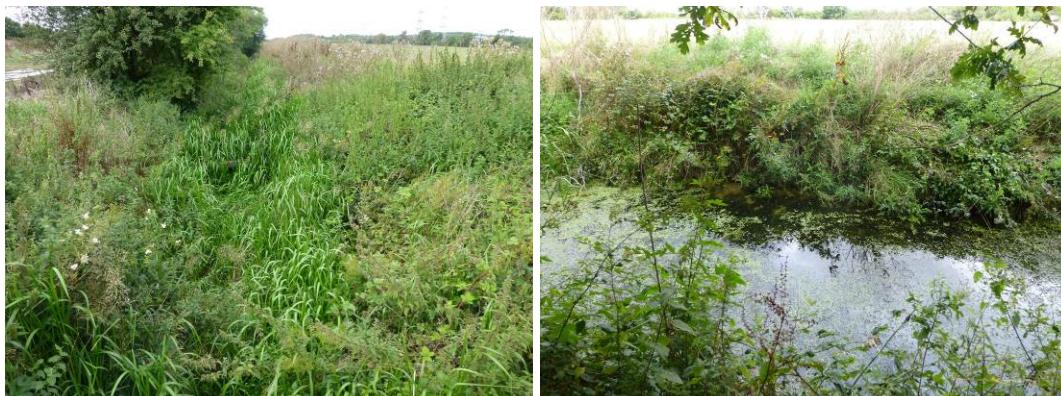
Figure 1: Engine Dike

The eastern extent of the watercourse is heavily shaded by hedgerows, comprising Hawthorn *Crataegus monogyna* and some Rose *Rosa sp.* Visibility into the drain at this location is poor and the channel appears to be heavily vegetated. The majority of the drain surveyed contained extensive in-channel vegetation, including Reed Canary Grass *Phalaris arundinacea* and Duckweed *Lemna minor*. Along the banks scrub and trees, including Hawthorn and Oak *Quercus robur* are present, in addition to tall ruderal vegetation dominating the banks.

No Water Vole signs were observed during the survey.

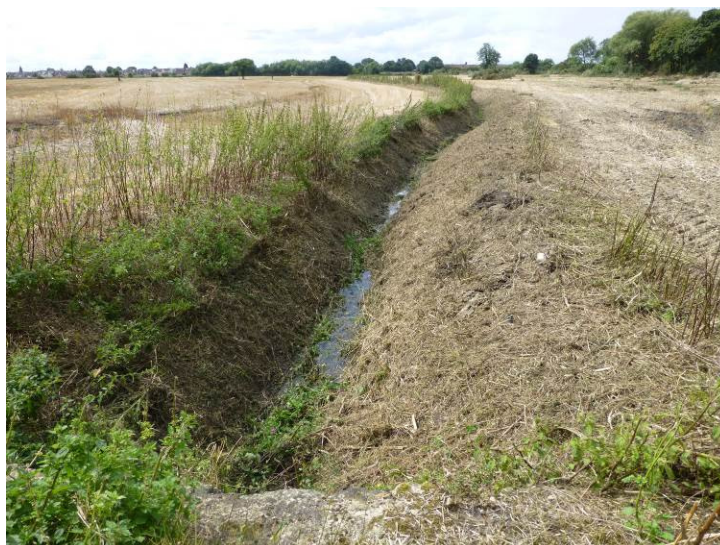
Figure 2: Fowler Bridge Drain

The drain intersects arable fields and has relatively steep sided banks. The channel contained little water at the time of the survey. The banks consist of ruderal vegetation, including Common Nettle *Urtica dioica*, however the banks had recently been flail mowed at the time of the survey.

No Water Vole signs were observed during the survey.

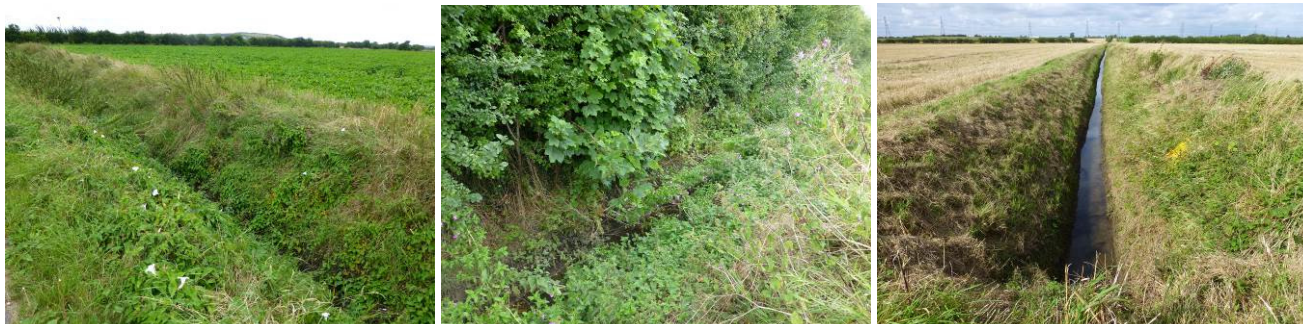
Figure 3: Kellington Drain

The majority of the channel that was surveyed was heavily shaded by bankside vegetation. At the northern end of the drain scrub and tall ruderal species, including Bracken *Pteridium sp.*, Bramble *Rubus fruticosus*, Common Nettle and Great Willowherb *Epilobium hirsutum* dominate the banks. The section of drain that runs along the west of Kellington Lane is partially shaded by a Hawthorn and Elder *Sambucus nigra* hedgerow and is dry in parts. Other species that are present along the banks at this location include

Bindweed and Bramble. At the southernmost extent of the drain the banks had been flail mowed.

No Water Vole signs were observed during the survey; however, the heavily shaded nature of the drain obstructed view of the channel. The section of the drain at the most southern extent offers good burrowing opportunities for Water Vole, however the majority of the drain is considered suboptimal for this species.

Himalayan Balsam *Impatiens glandulifera* is present on the banks at approximately OS grid reference SE 56079 24134 and SE 55700 23218.

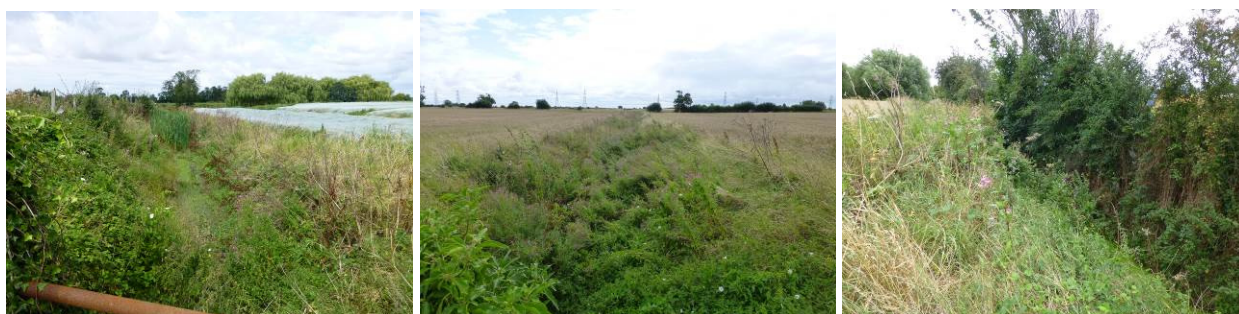
Figure 4: Kellington Lane Drain

The northern extent of the drain, north of Roall Lane, is heavily vegetated with Reedmace *Typha latifolia* present in the channel. The drain to the south of Roall Lane is also choked with vegetation and the banks are dominated with scrub and ruderal species including Great Willowherb, Bramble, Bindweed, Thistles *Cirsium* sp. and Hogweed *Heracleum sphondylium*. Towards the southern extent of the drain, the banks remain dominated with tall ruderal species and partially shaded by scrub comprising Willow *Salix* sp.. Himalayan Balsam was present along the length of the drain, particularly south of Roall Lane.

No Water Vole signs were observed during the survey; however, the heavily shaded nature of the drain obstructed view of the channel.

Himalayan Balsam *Impatiens glandulifera* is frequent along the banks of the drain south of Roall Lane.

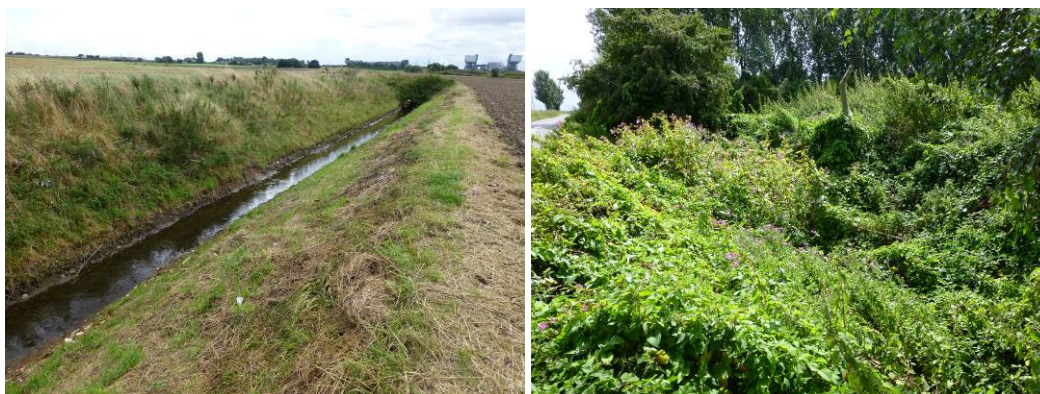
Figure 5: Woodholmes Drain

The majority of the drain intersects arable fields. Tall ruderal species were present on the banks, including False Oat-grass *Arrhenatherum elatius*, Common Nettle and Great Willowherb, however, most of the bankside vegetation had been recently cut. At the southern extent of the drain, that is adjacent to Sudforth Lane, the drain is heavily shaded by vegetation, including Bindweed, Bramble, Common Nettle and Himalayan Balsam.

Water Vole activity was recorded along the drain with burrows and footprints observed. Burrows were present at approximately SE 52300 24886, SE 52240 24828 and footprints were recorded at approximately SE 52301 24641.

Himalayan Balsam is present at SE 53089 23994.
