Shire
Group of IDBs

Black Drain toe piling Black Drain opposite The Dutchman

Environmental Appraisal

September 2017

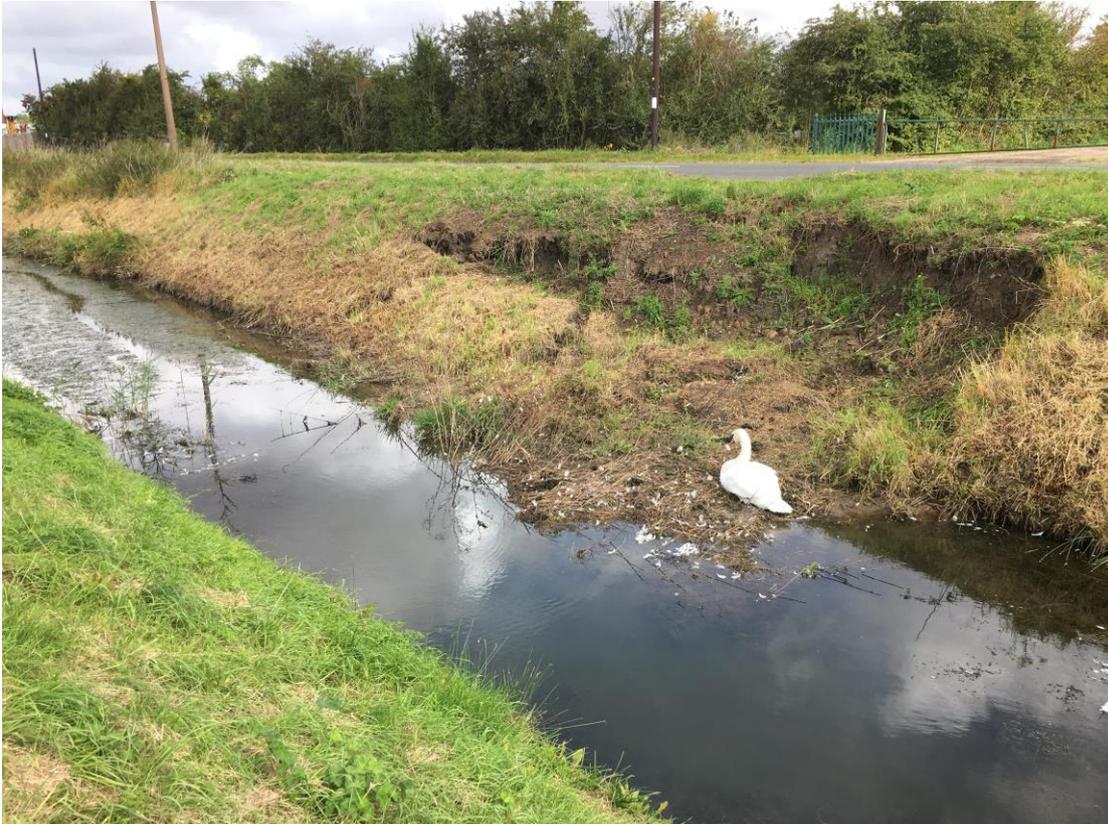
Figure 2: slip facing north east

Timber toe piling of approximately 20m length at the base of the slip on the Highway side of the watercourse. (see Figure 2)

Board maintained strategic watercourse Black Drain has suffered bank slips on the highway side of the watercourse. The slip is a recent occurrence and has occurred immediately adjacent to a burst water main incident earlier in 2017 on Moorends Road.

The section of watercourse slip is 20m in length immediately adjacent to the highway. The depth of the drain from bank top is approximately 3m, depth of water at the time of survey less than 30cm.
