General details

Drain Name

Ravensfleet Area

Survey Date

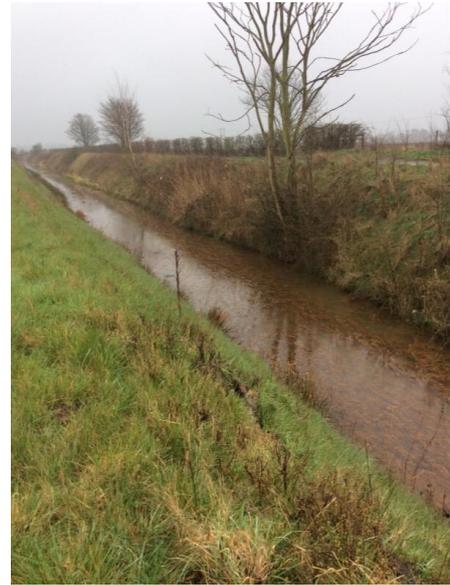
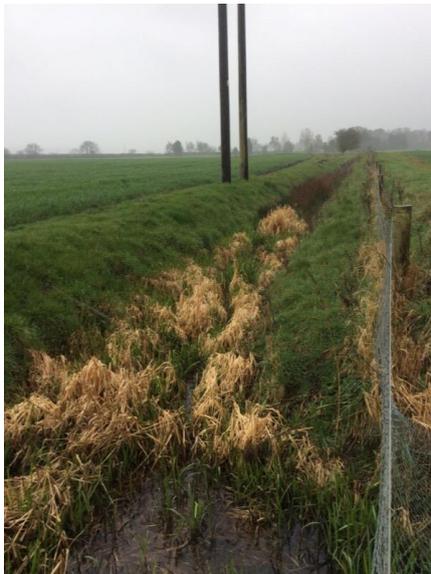
Plowland Drain to Ten Foot Drain section. Large stands of broad leaved pondweed (*Potamogeton natans*), native to slow flowing freshwater habitats. Scattered small stands of the large perennial grass Common Reed (*Phragmites australis*) at drain edges. Small stand of water starwort (*Callitriche sp.*) at junction with Ten Foot Drain. No evidence of water vole (*Arvicola amphibious*).

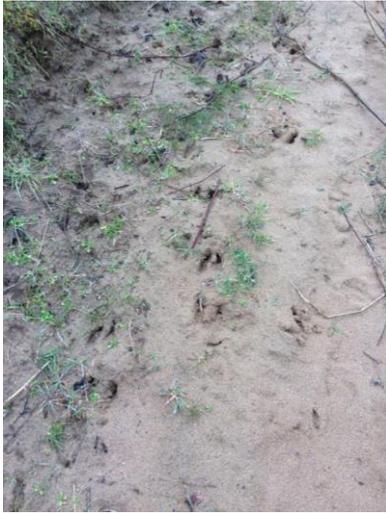
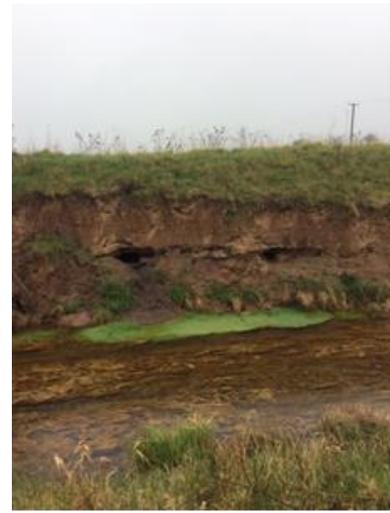
Ravensfleet Warping Drain

The drain carries extensive stands of broad leaved pondweed (*Potamogeton natans*) and stands of water starwort (*Callitriche sp.*). The section of the drain within the 50m section either side of NGR: 481813, 394703 and its bank tops are formed from well-rounded grains of sand with evidence of use by multiple deer, evidenced by footprint and faeces, fresh with a high moisture content, likely made within the previous 6-12 hours.

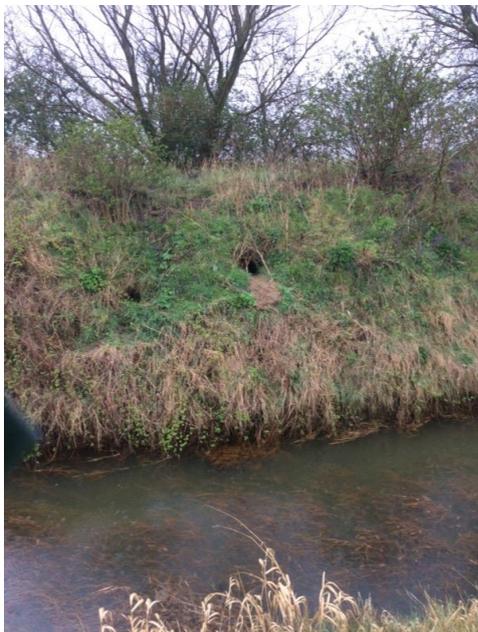
Further downstream the south bank contains an abandoned badger (*Meles meles*) sett which it is understood was closed by the Board a number of years ago. The opposite bank contains a large number of burrows however there was no visible evidence of tracks to the upper bank which badger would create and it is assumed the burrows are likely occupied by rabbit (*Oryctolagus cuniculus*), size being created by sand crumbling away during use.

Within 50m downstream of this point, more burrows are evident with a large amount of spoil on the bank and tracks through the vegetation were evident. This could be a new badger (*Meles meles*) sett but without further investigation of the north bank this cannot be confirmed. Kingfisher (*Alcedo atthis*) was observed flying downstream over the drain. No evidence of water vole (*Arvicola amphibious*) was seen.
