Environmental Survey Great Catchwater

Scunthorpe & Gainsborough
Water Management Board

This document has been prepared following walk over surveys of Great Catchwater Drain in which the Board is undertaking maintenance under a PSCA with the Environment Agency. JBA Consulting accepts no responsibility or liability for any use that is made of this document other than by the Client for the purposes for which it was originally commissioned and prepared.

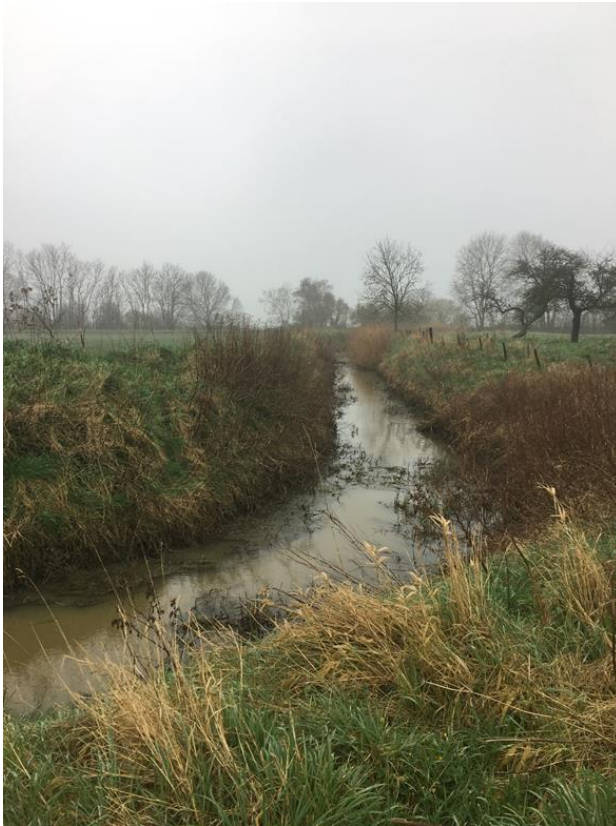
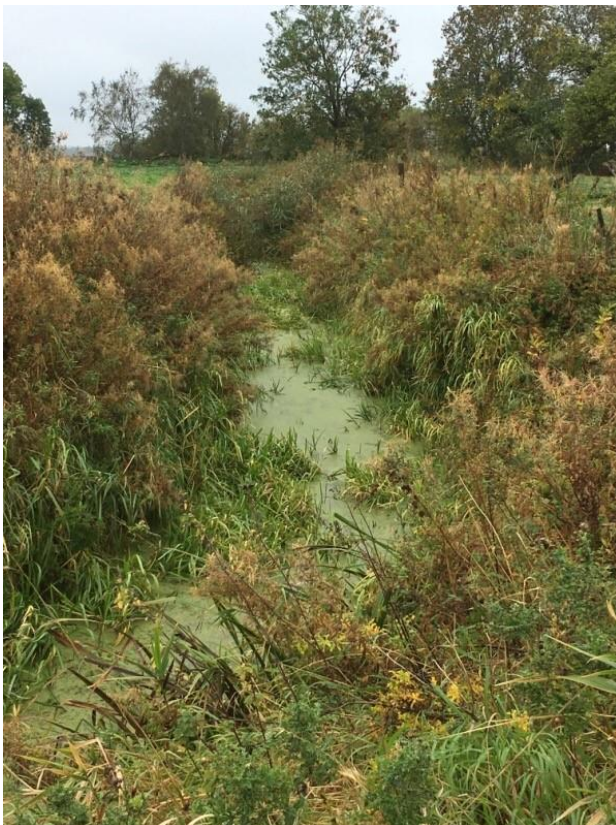
Surveys were undertaken week commencing 15th October 2018 on the full extent of Great Catchwater Drain. Site photographs Figures 2 - 9 compare growth on bank and in channel between April 2018 and October 2018 site visits.

The watercourse is dominated by Common Reed (*Phragmites australis*) among rank grasses associated with nitrogen rich ground adjacent to farmland. Occasional small stands of Meadowsweet (*Filipendula ulmaria*) were noted.

Figure 2.1: Great Catchwater April 2018 150m upstream Ravensfleet outfall

Figure 2.2: Great Catchwater October 2018 150m upstream Ravensfleet outfall

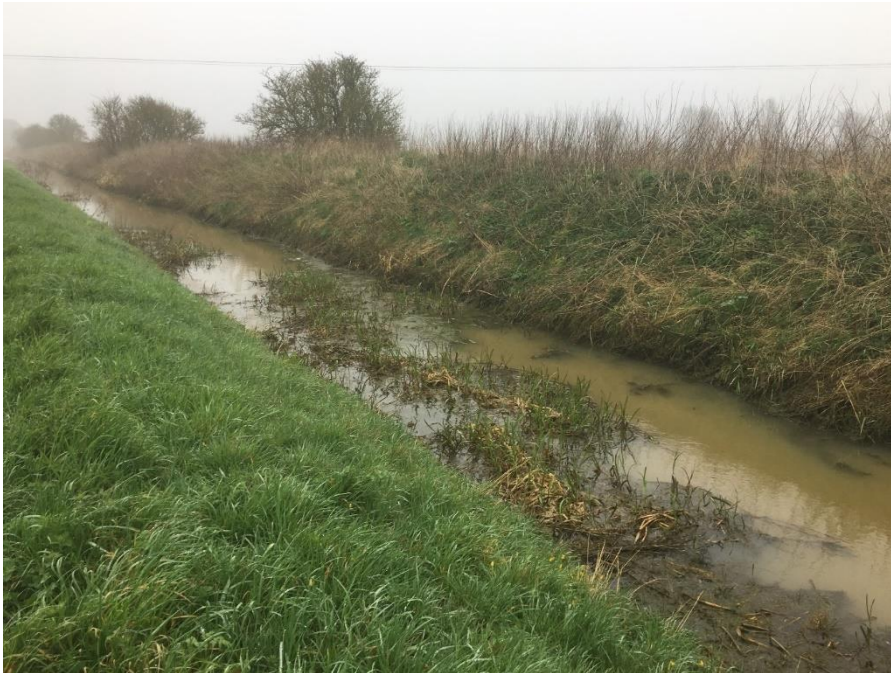
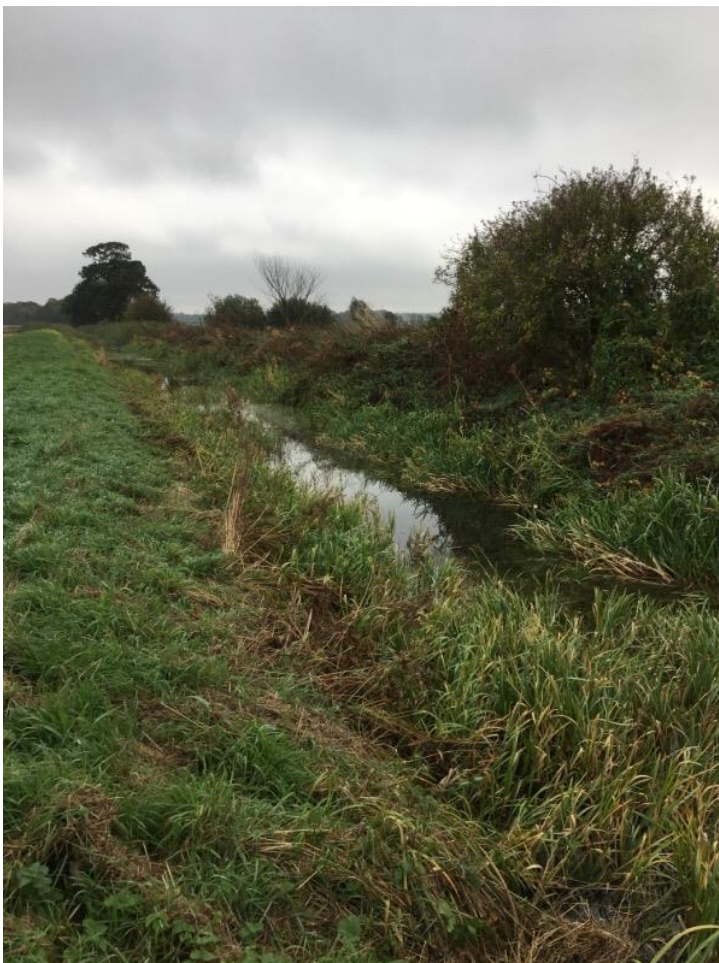
Figure 3.1: Great Catchwater 400m upstream of Warping Drain outfall April 2018

Figure 3.2: Great Catchwater 400m upstream of Warping Drain outfall October 2018

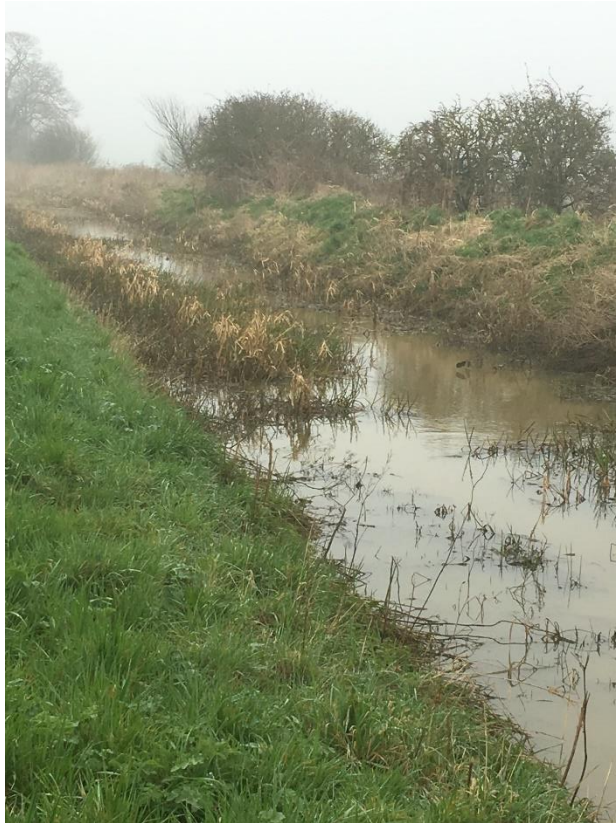
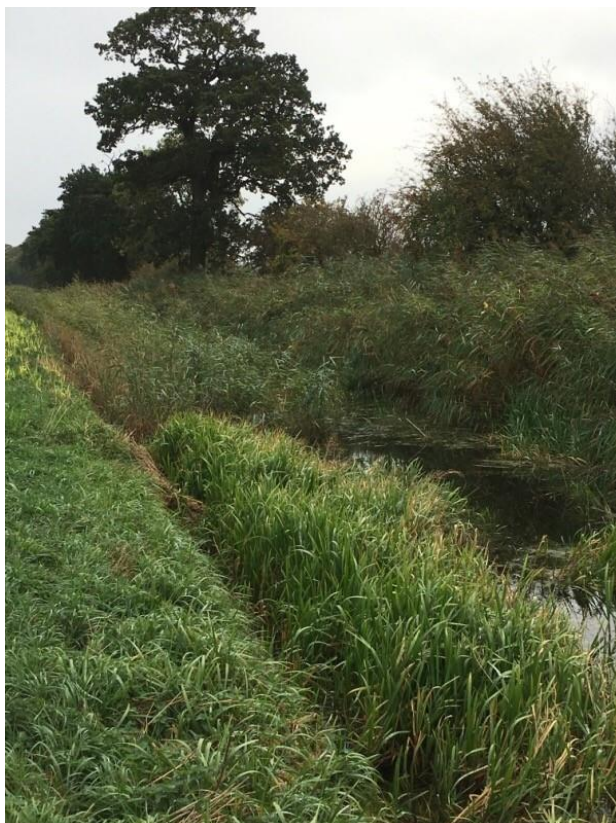
Figure 3.1: Great Catchwater emergent Phragmites

Figure 3.2: Great Catchwater emergent Phragmites October 2018

De-weeding work is the removal of emergent growth from the watercourse channel using a Bradshaw bucket with knives which cut through roots. This work will be undertaken outside the fish spawning season, which depending on species, typically spans the months of April – July. Great Catchwater drain has a lack of favourable spawning substrate and the fish species present will spawn chiefly on aquatic plants and marginal vegetation. De-weeding works will be undertaken sensitively, the centre of the channel only will be cleared of vegetation, a fringe being retained within the watercourse at the base of both banks. Arisings will be placed on the opposite bank top/sides.

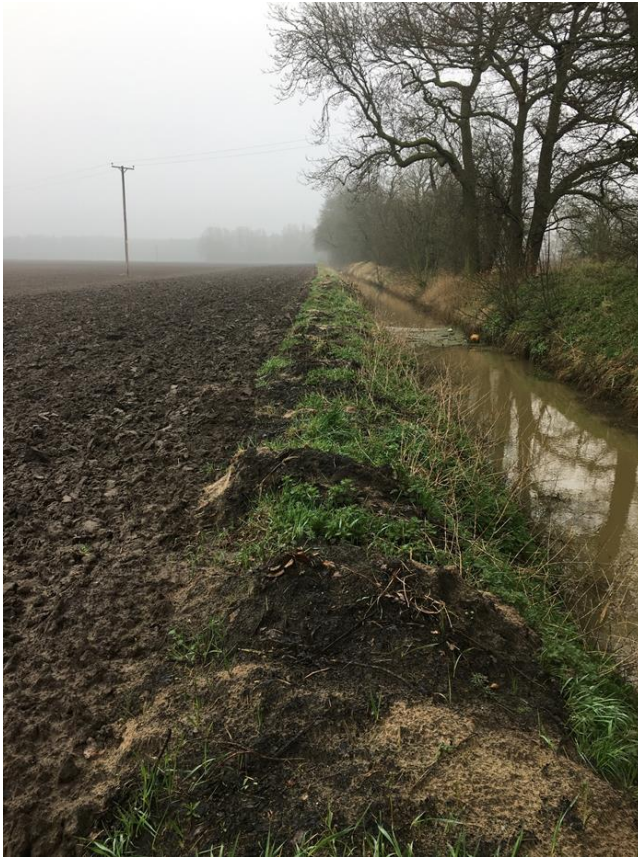
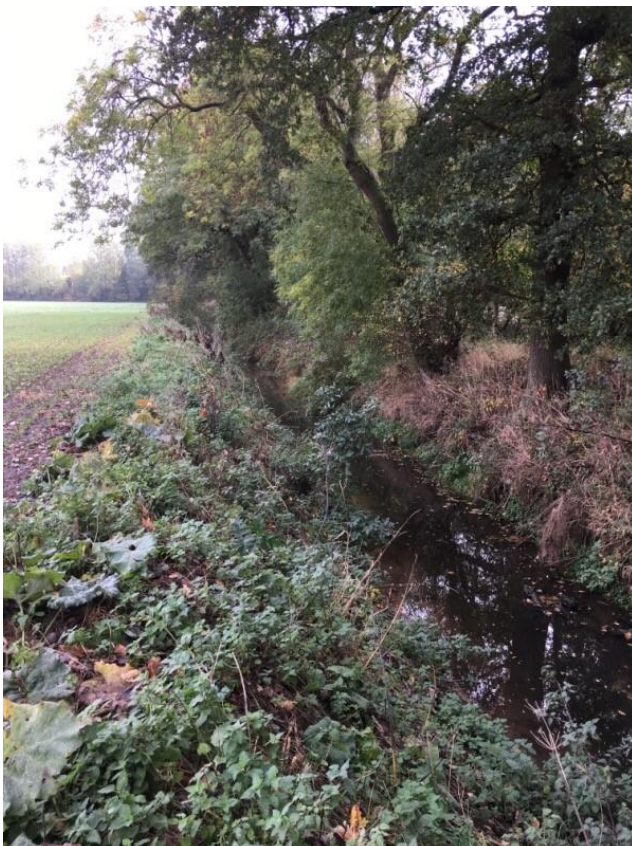
Figure 4.1: Great Catchwater 500m downstream Cuckoo Cottage April 2018

Figure 4.2: Great Catchwater 500m downstream Cuckoo Cottage October 2018
