## Environment Agency Recovery Works Old River Ancholme

Following those inundation events, as part of its post event inspection, the Environment Agency identified some repair work necessary in the landward toe of the old river Ancholme flood embankment, proximal to the railway bridge (Site 2) and similar work required further south on the old Ancholme off Cadney Road (Site 1).

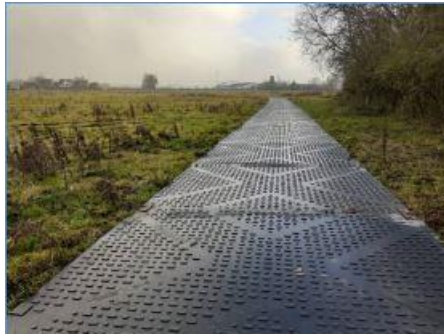
← Access track to site

On site work is being delivered through our contractors which works commenced with the installation of rubber trackway and setting up fencing and ropes in the field to segregate livestock. By 20<sup>th</sup> November, plant machinery, welfare and security had been established on site ready to commence excavation works the following week.
