River Lugg Internal Drainage Board

Annual Works for Flood Prevention and Biodiversity Enhancement

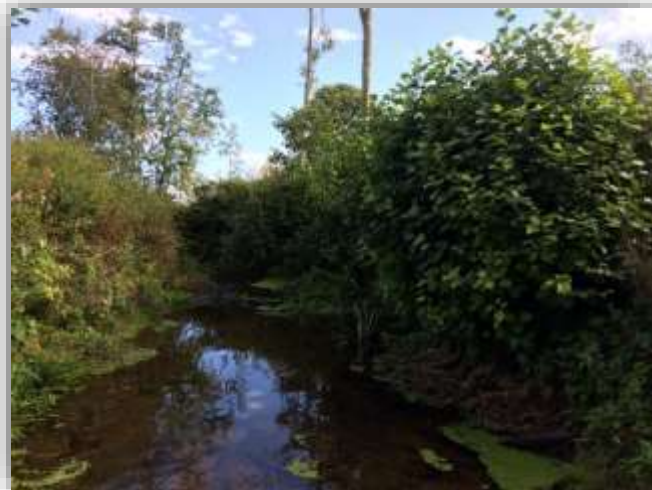
provided along the watercourse; the latter is achieved by retention of mature specimen trees, coppicing and laying to provide areas of dense foliage and wildlife cover, and manipulation of shading to encourage macrophyte growth within the channel. In addition, bankside tree management also includes management of dead and diseased trees.

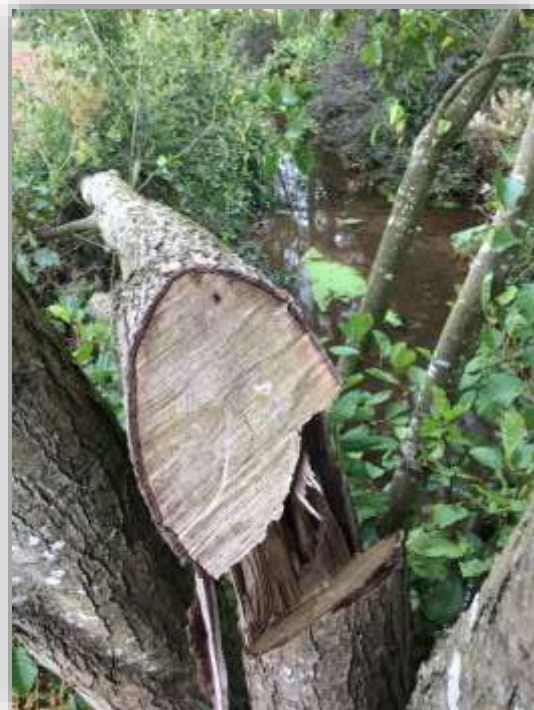
Alder are one of the most common species along Herefordshire's waterways, easily able to colonise the damp soils. However, in recent years this species has suffered from increasing levels of Phytophthora disease, which can result in the tree and surrounding bank becoming unstable. The RLIDB coppices diseased trees to prevent bank instability and to encourage regeneration of new growth from the stool and root system.

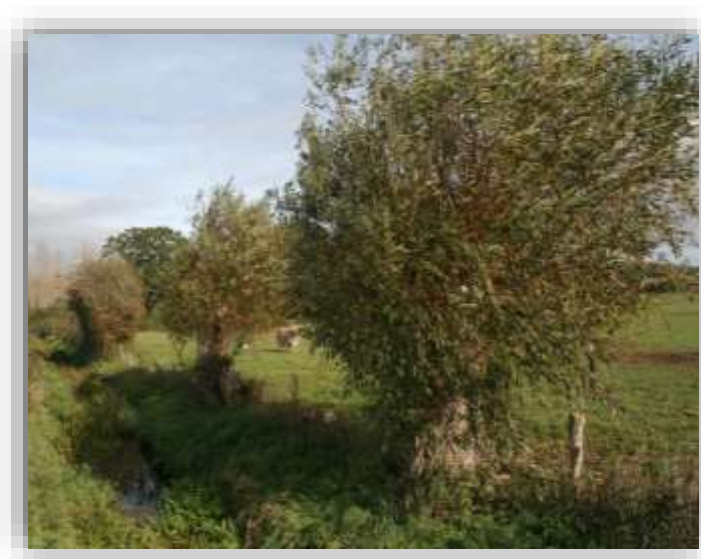
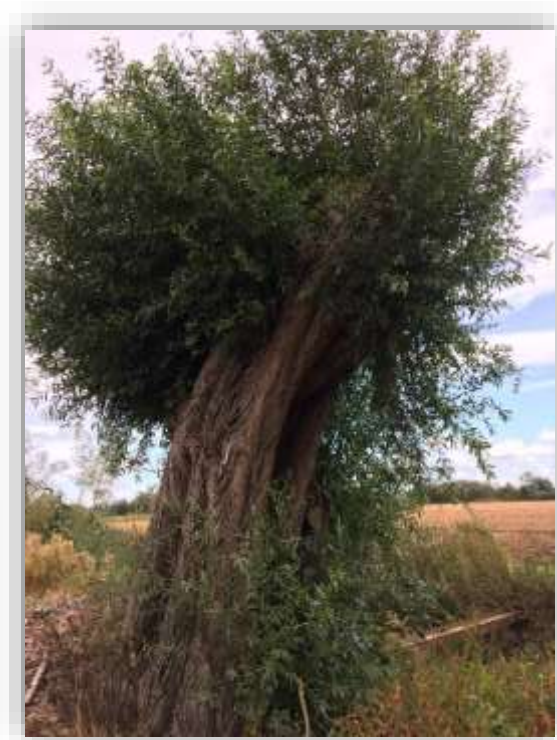
The RLIDB pollards bankside trees on a rotational basis of roughly 8-12 years, or depending upon species and need. Work is carried out during the winter by chainsaw/cherry picker, with the whole crown pollarded at roughly 2-2.5 m above the ground. This avoids

instability problems associated with partial pollarding. The cut material is routinely used in bank revetment works or may be used to create piles of dead wood for additional habitat.

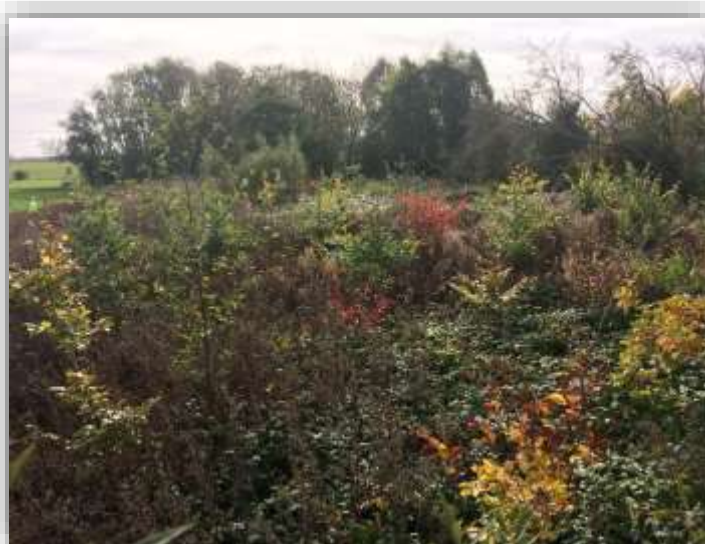
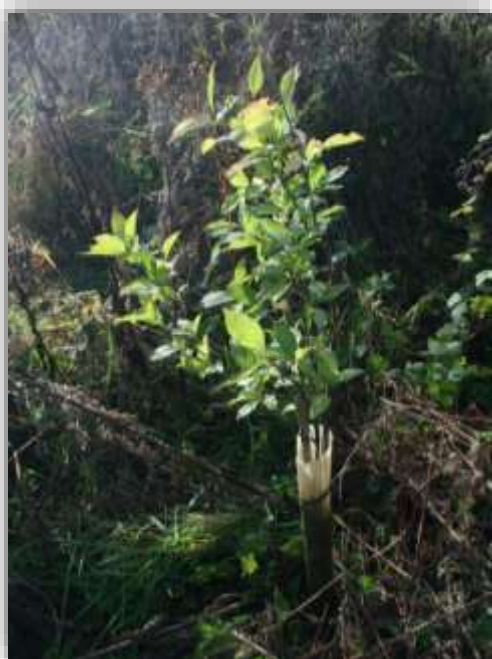
The RLIDB undertakes tree/shrub planting where opportunities arise. For example, approximately 300 trees and woody shrubs, including English oak, field maple, beech, rowan, hazel, spindle, dogwood and holly, were planted in 2016 along a 3 km section of the River Lodon, which the RLIDB maintains. Planting was carried out around existing clumps of bramble, leaving some open areas so as to provide a structurally diverse habitat buffer to benefit a wide variety of plant and animal species.

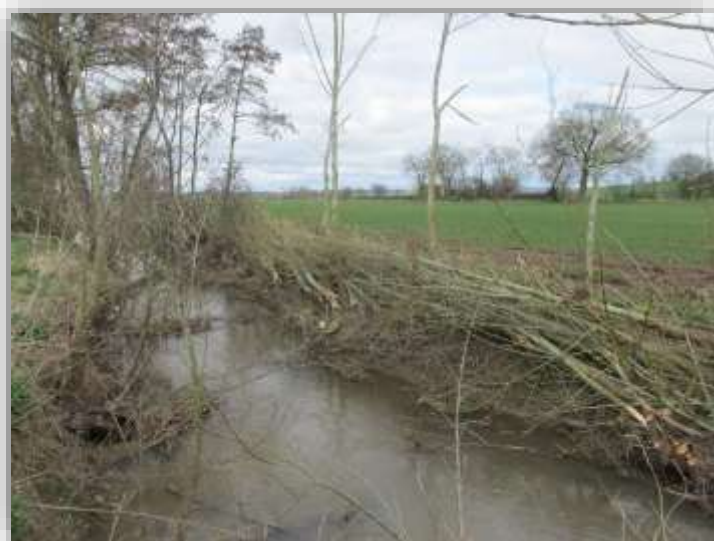
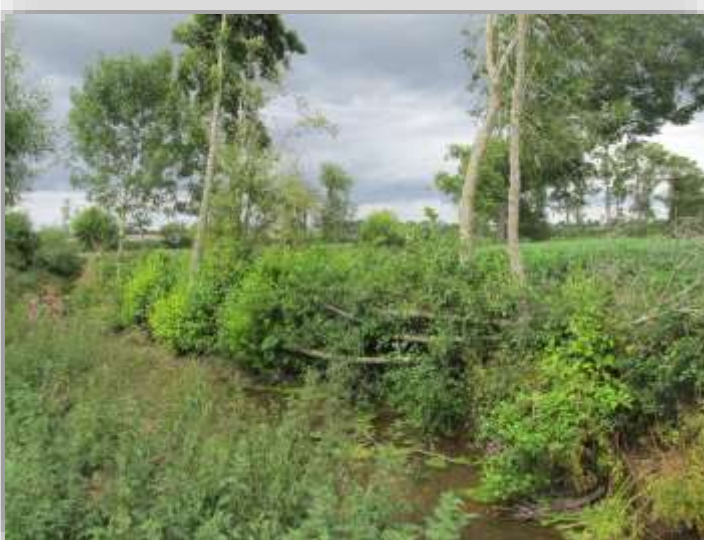
The RLIDB employs soft engineering techniques to create natural

revetments, deflectors and berms in areas of high erosion and bank instability in order to dampen strong river currents during flood conditions. A mixture of live coppiced stems and/or cut stems is routinely used to create natural deflectors and revetments with the stems pinned in place by wooden stakes, and with the brush piled behind. The coppiced trees are allowed to regenerate while protecting the bank behind; the high regenerating capacity of willow and alder means that such features created over the winter months often comprise dense vegetation by the following summer. These features provide excellent cover for nesting birds and otters. Berms are also introduced to achieve flood conveyance during high flows, but also provide additional geomorphological variation to the watercourse and, once established, provide new bankside habitat.

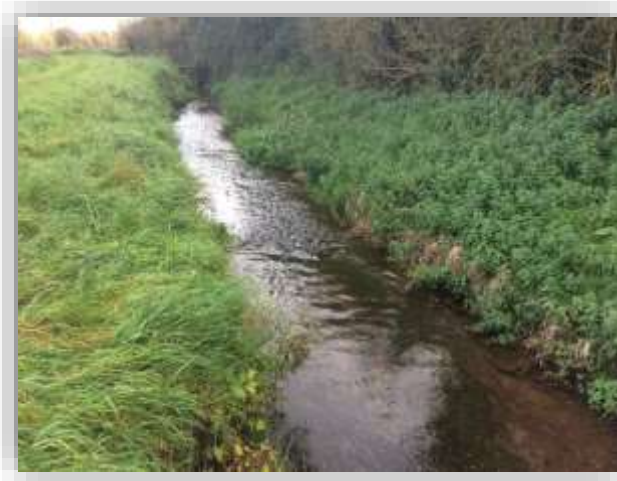
In the relatively straight watercourses of field boundaries, a pool-riffle sequence can be introduced by installing shallow berms at intervals across the bed of the watercourse. This has been undertaken on several RLIDB watercourses with the result mimicking a more natural pool-riffle sequence, providing heterogeneity to the flow and associated ecological benefits to the watercourse.

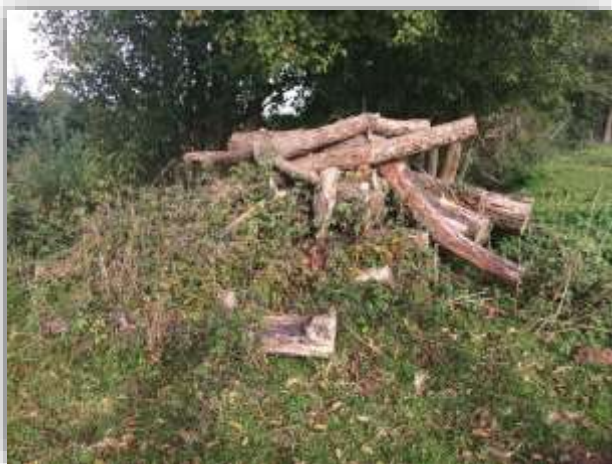
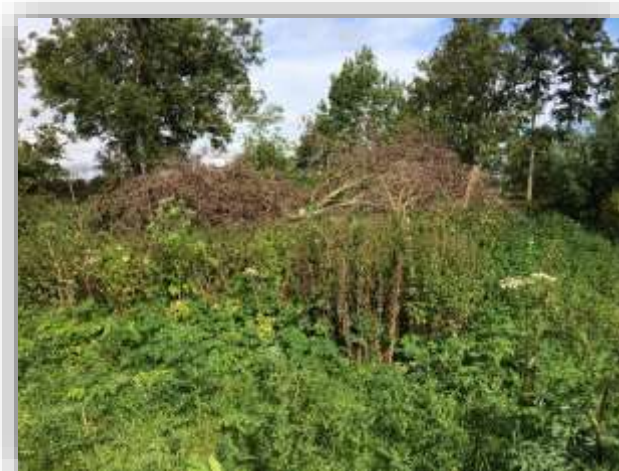
The RLIDB routinely creates piles of brush and deadwood, as a result of its tree works, along its watercourses, where space allows.

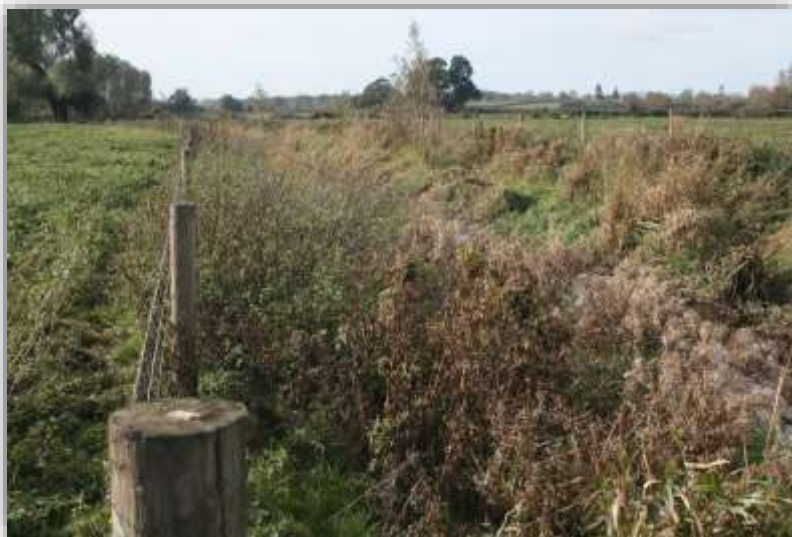
Where opportunities arise, and funding is available, the RLIDB will install fencing to protect sections of watercourse banks, and thus provide a buffer between grazed areas and the watercourse. Areas

between the fencing and channel are colonised by semi-natural habitats providing further enhancement of the riparian corridor.

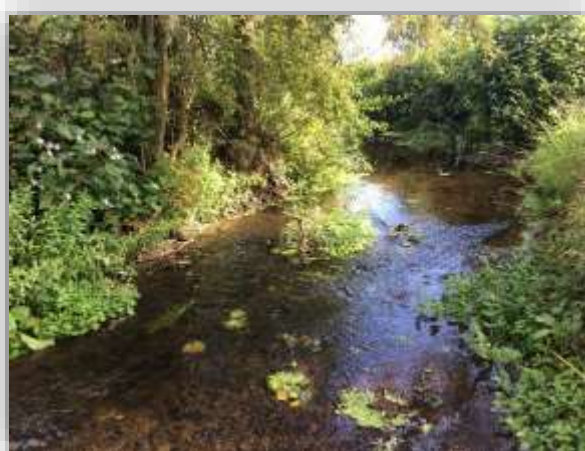
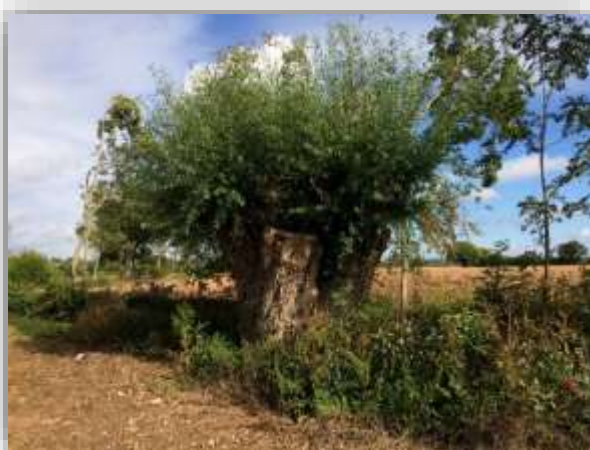
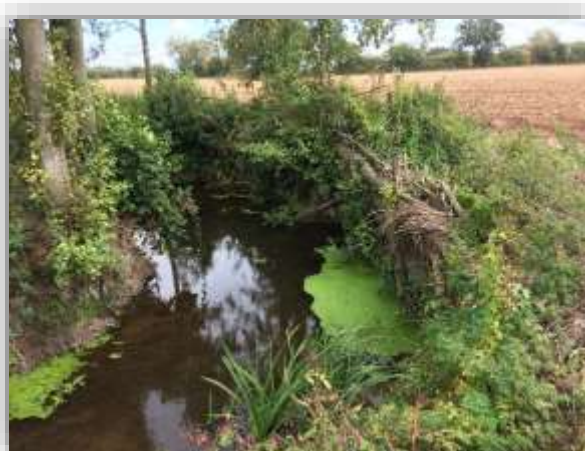
Prior to RLIDB management in 2017, the brook had been unmanaged for a number of years and suffered from overshading, accumulation of debris with large limbs blocking the channel, formation of erosion holes, soil/substrate loss and associated

smothering of bed gravels, and a lack of pollard management.

undertook works which included laying existing lines of young alder along the bank while retaining suitable specimen trees, creating several soft-engineered 'live' bank deflectors to minimise further erosion, and pruning neglected pollards along the watercourse. This restored bed gravels, reduced the dense shading of the channel and created a good structural mix of bankside vegetation, with dense cover for nesting birds, otters and other animals.
