Environment Agency Recovery Works Old River Ancholme and its tributaries

Summer and autumn 2019 rainfall

Recovery work sites

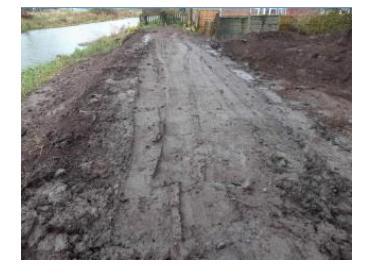
These sites are immediately south of Brigg, Site 1 relates to Island Carr, and Site 2 is just off the Cadney Road. For both sites, recovery work is association with remediation of berm and bank

erosion. On **Site 1** just before the Christmas break, work focussed on the completion of the seepage point area bringing this to the required finished height then moving onto rebuilding the embankment where 1 of 2 tree stumps were previously located.

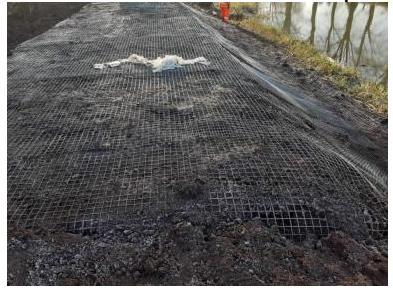
After Christmas the 2nd stump location was compacted, clay shaped and formed to the original profile as shown in these three pictures left and below. Netting to reduce burrowing was laid and covered with 200mm of topsoil.

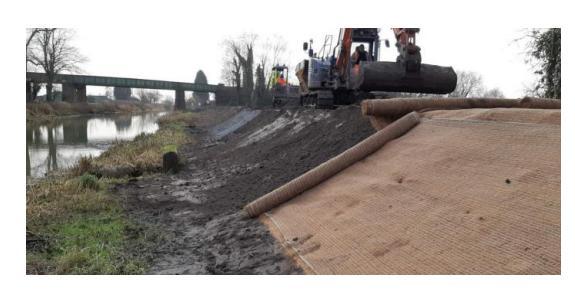
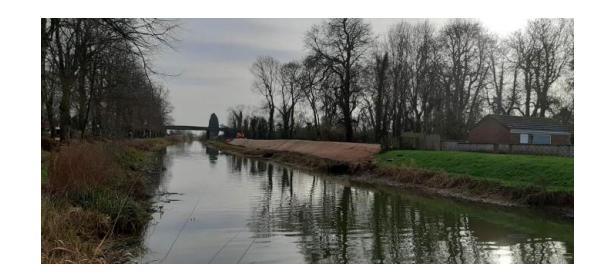
By the end of January, however works at both sites were 60% complete on dressing and forming the embankment tops and sides with topsoil, fixing

At **Site 2** shown below, areas of the river bank repair were completed however top soiling works were held up by heavy showers raising water levels.

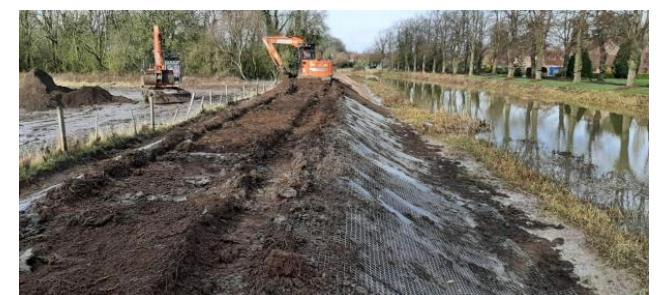
good days of weather that week, Contractors installed netting, laid top soiling, and undertook seeding work.

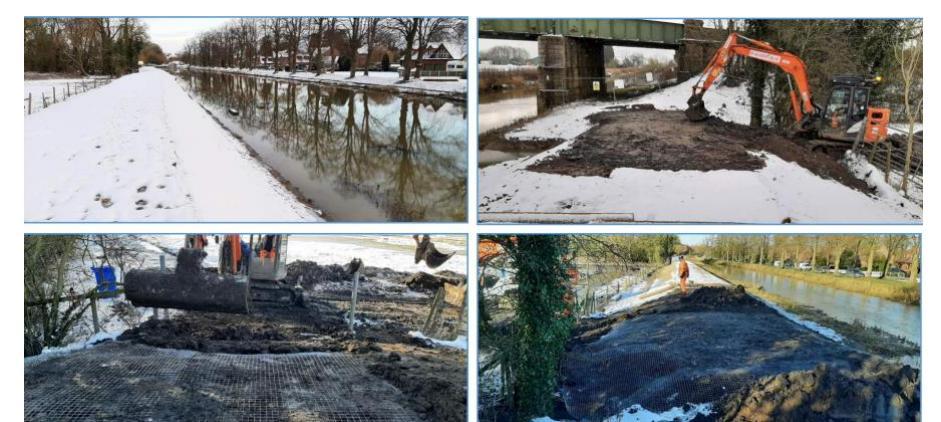
Contractors mitigated time lost by cutting bio netting to size and stockpiling top soil adjacent to the embankment.

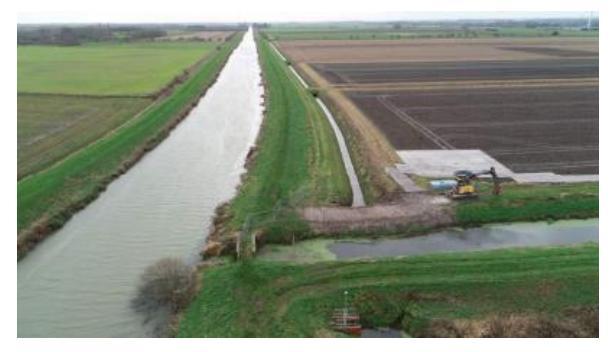
By the end of February at Site 1 as weather conditions improved, the trackway and welfare compound been had removed and the field, entrance fencing and gate had been reinstatement.

Contractors also top soiled and seeded roughly 100 metres of

verge on both sides of Mill Lane, stoned up the site entrance way as a goodwill gesture to the landowner. The site is now cleared.

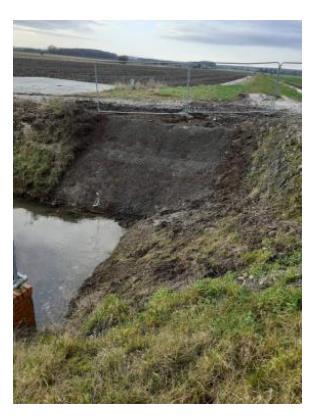
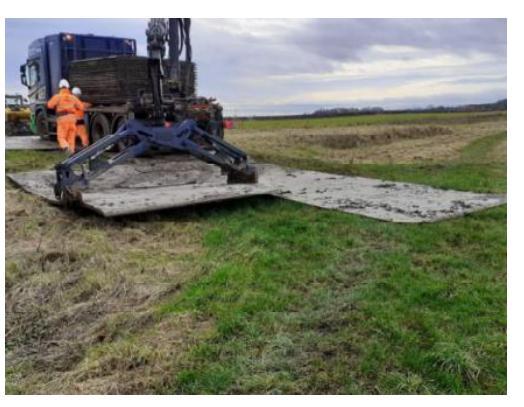
During the first week of January, netting to discourage burrowing was installed, its surface topped and top soiled ready for seeding.

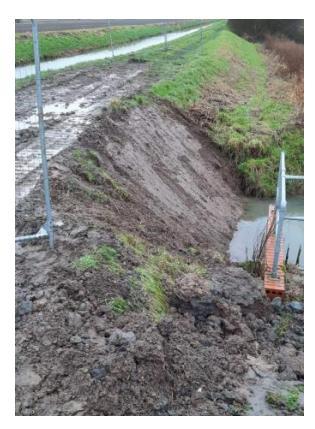
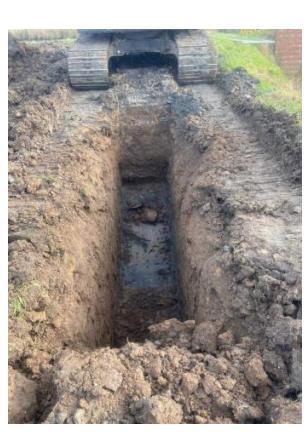
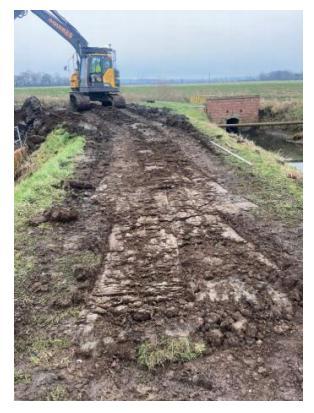
On 18th-20th January, Storm Christoph delayed crest works due to excess rainfall and localised flooding. Water levels were too high to excavate into the embankment which could have resulted in flooding of the excavated site.

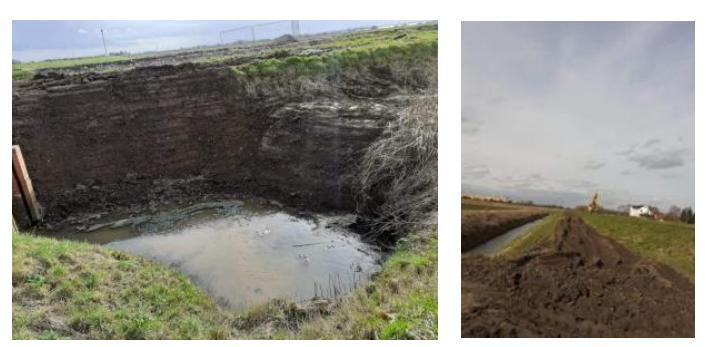
By the end of the month reinstatement of both north and south side bank crests had been reinstated as weather improved. Only top soiling, seeding and protective covering work is required at site to complete the work.

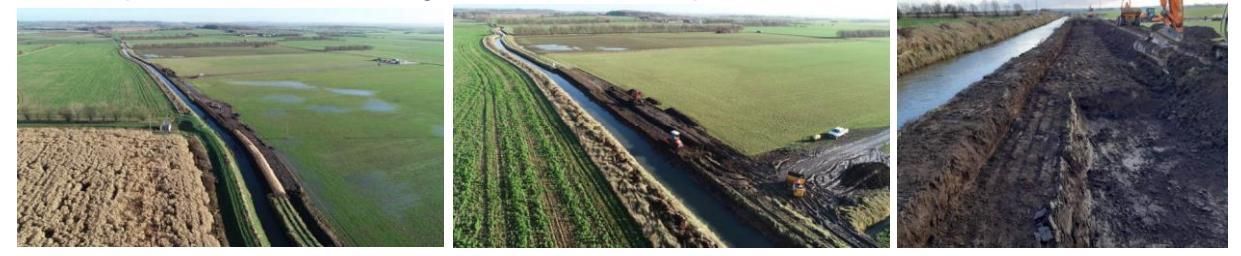
Recovery work on Kettleby Beck, just south of Brigg is associated with overtopping and seepage. The week before Christmas, works focused on completing the fourth of five 50m sections of the additional 250m embankment rebuild. Topsoil was stripped off and benches were excavated into the embankment. This was rebuilt using imported cohesive fill and, when at the required height, was shaped and trimmed through to the level and top soiled.

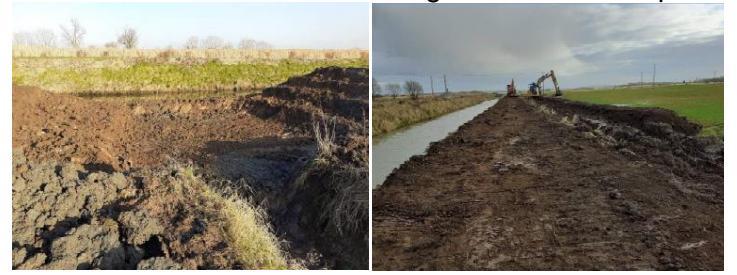
Work recommenced in the New Year with a topsoil strip of sections 2 and 3 of the 250m section of additional embankment raising works. Whilst a precautionary ecological check of the area was

being undertaken, works moved to excavation of an additional seepage point at the start of the embankment works. With the formation and benching completed, geogrid was placed every 300mm with layers of imported cohesive material which was compacted filling the area to its original profile.

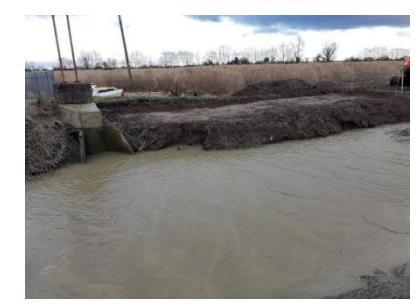
A gang started operations on the north side of the embankment shown in the picture on the left.

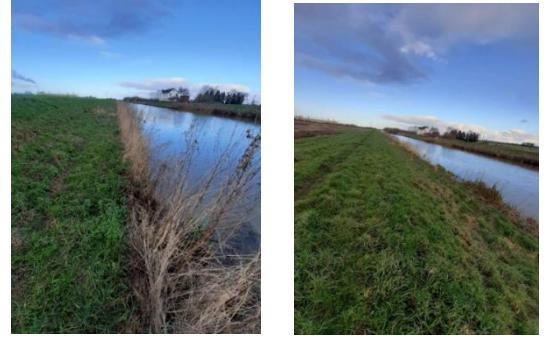
Strimming of the sites commenced in the New Year. This work is associated with bank erosion opposite the Ancholme IDB pump stations at Worlaby Carr and Broughton.

By mid-January strimming was completed and debris cleared. Preparation for coir roll installation works was being delivered in tandem with work at Hibaldstow. Trackway installation was required to gain access with plant and materials.

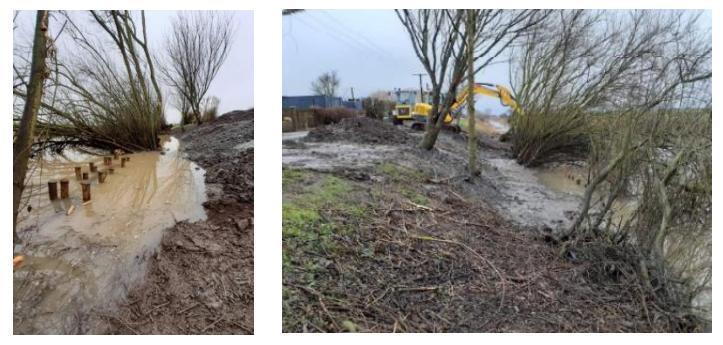
installation for the Contractors. The first job was strimming the site and removing brash from around the coir area. However as at 14th January, river levels had increased significantly preventing any excavation works. Contractors managed to work through at this site until Storm Christoph raised river levels overnight by 1m.

Strimming was however completed and a significant volume of dead material and brash removed permitting access.

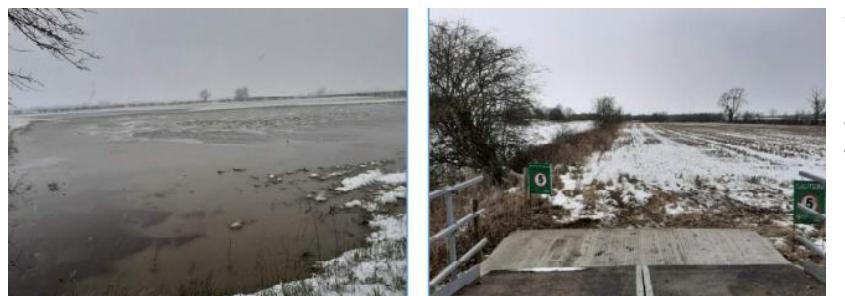
Work in the last week of January progressed well; willow trees landside of the river were removed and chipped allowing access to bank base. All required materials were on site including 80t of compacted clay to provide a working platform from which to place the stakes, brushwood faggots and coir rolls. Unfortunately by mid-day at the end of the week, the river was too high for

Water levels were too high and no safe work could be undertaken; fields to the west of the properties were flooded. By Tuesday of the second week, although water had receded to some extent, it remained too high for work as run-off from surrounding fields continued to
